Report
Scratch resistance, chemical resistance and weathering
resistance of a coating system of Optimum Car Care B.V.

Report number: 89204199.1

Author: Ton. M. Agterberg, B.Sc.

Date: November 7th, 2013

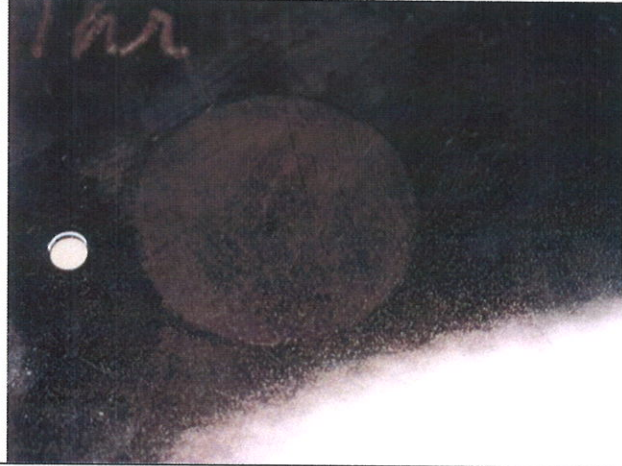
Photo 1, After 1 hour of exposure to hydrochloric acid.	Photo 2, After 1 hour of exposure to phosphoric acid.

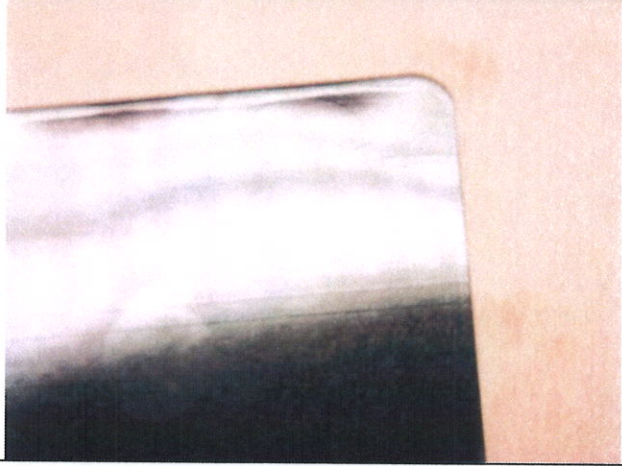
Photo 3, After 1 hour of exposure to ethanol.
